PRESALE REPORT

33 Wellington Street

Ngunnawal

16 October 2025

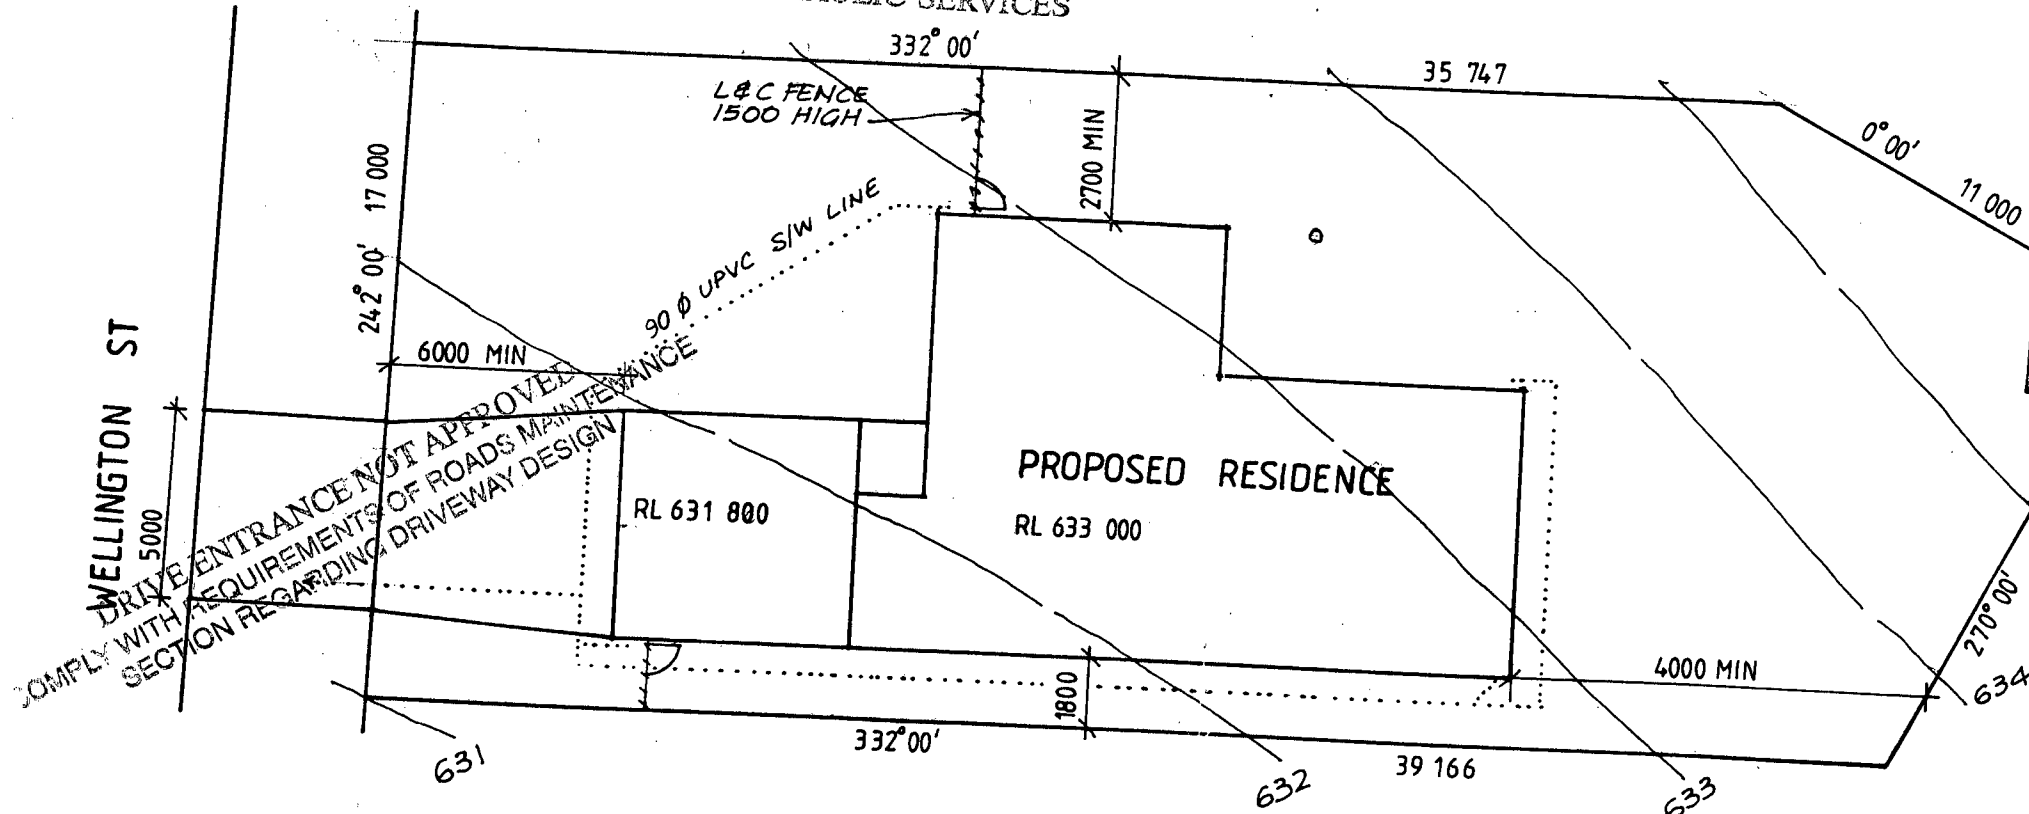
THE PERMIT HOLDER IS TO LIAISE WITH
 THE LAND DEVELOPER TO ENSURE
 THE BUILDING IS SITED CORRECTLY
 WITH REGARD TO HYDRAULIC SERVICES

DRIVE ENTRANCE NOT APPROVED
 COMPLY WITH REQUIREMENTS OF ROADS MAINTENANCE
 SECTION REGARDING DRIVEWAY DESIGN

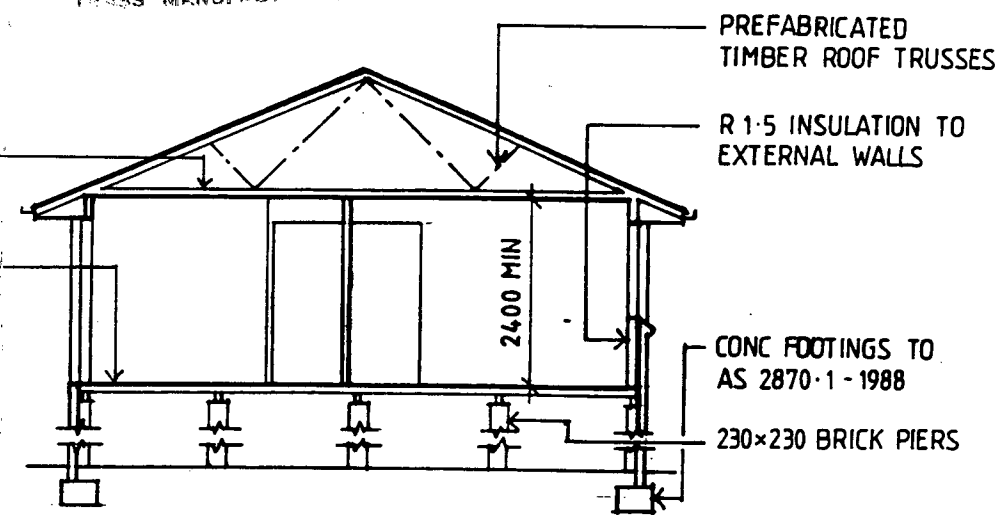
SECTION A

R3 INSULATION
 19mm 'AQUABAR' FLOORING
 ON 100x50 TIMBER JOISTS AT
 450 C/S & 100x75 BEARERS
 ALL TO AS 1684-1979

FOOTINGS/SLABS
 APPROVAL IS GIVEN SUBJECT
 TO CONDITIONS OF
 SITE CLASSIFICATION-ENGINEERING
 OPTION

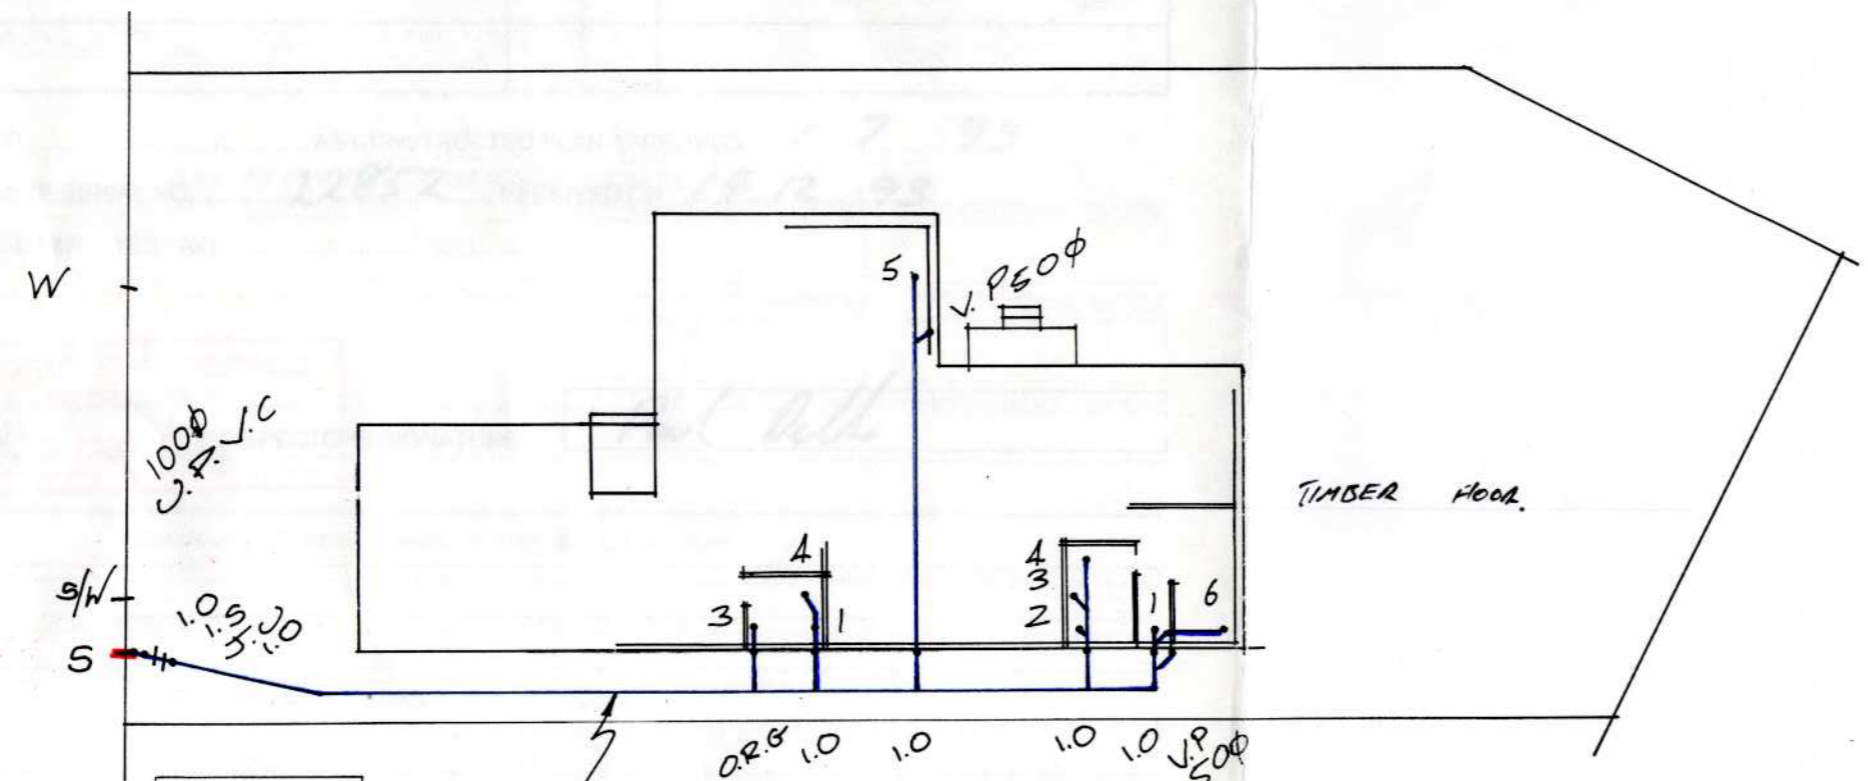
SEWER
 Tie: 2.2m
 Depth: 1.8m
 Chainage: 27.3m

STORMWATER
 Tie: 3.4m
 Depth: 1.1m
 Chainage: 23.2m
