# Residential REPORTS

## PRESALE REPORT

**1/4 Twine Place**

Monash

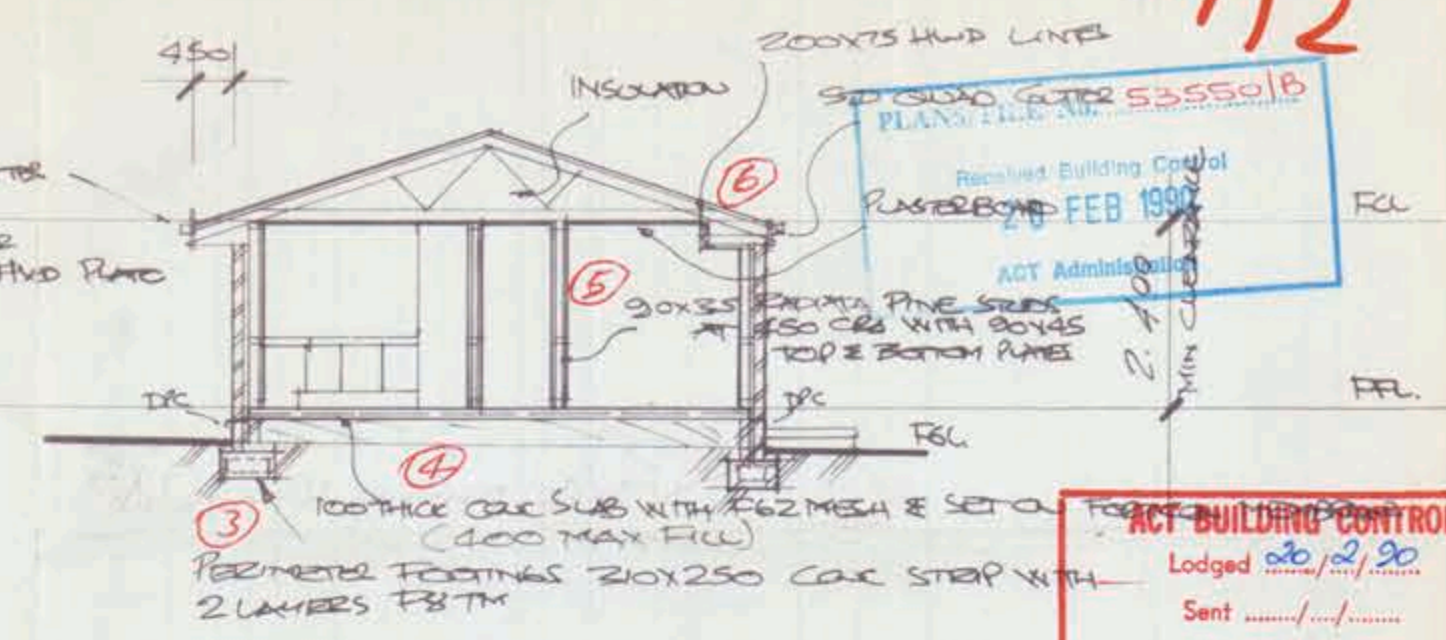
TYPICAL SECTION 1:100 ✓

Fire Resistance to Comply with Part C1.9 B.C.A.

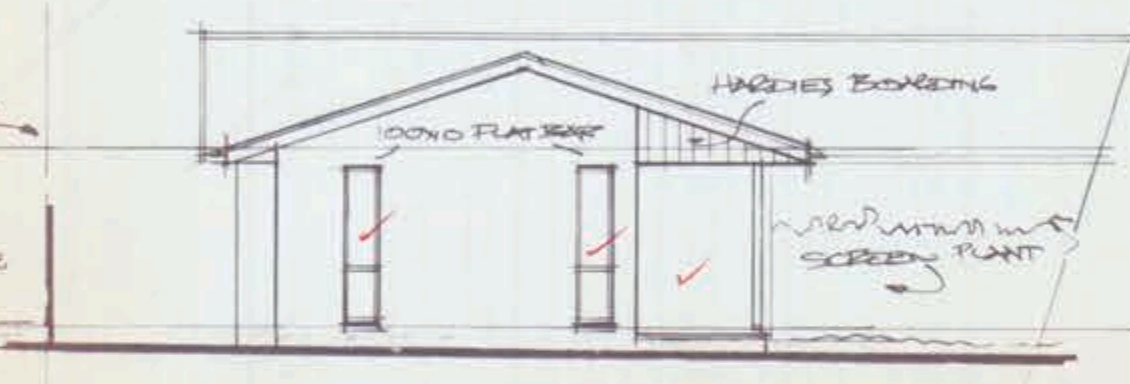
REAR ELEVATION 1:100 ✓

Damp & Water penetration TO COMPLY WITH PART 1.9 BUILDING CODE OF AUSTRALIA

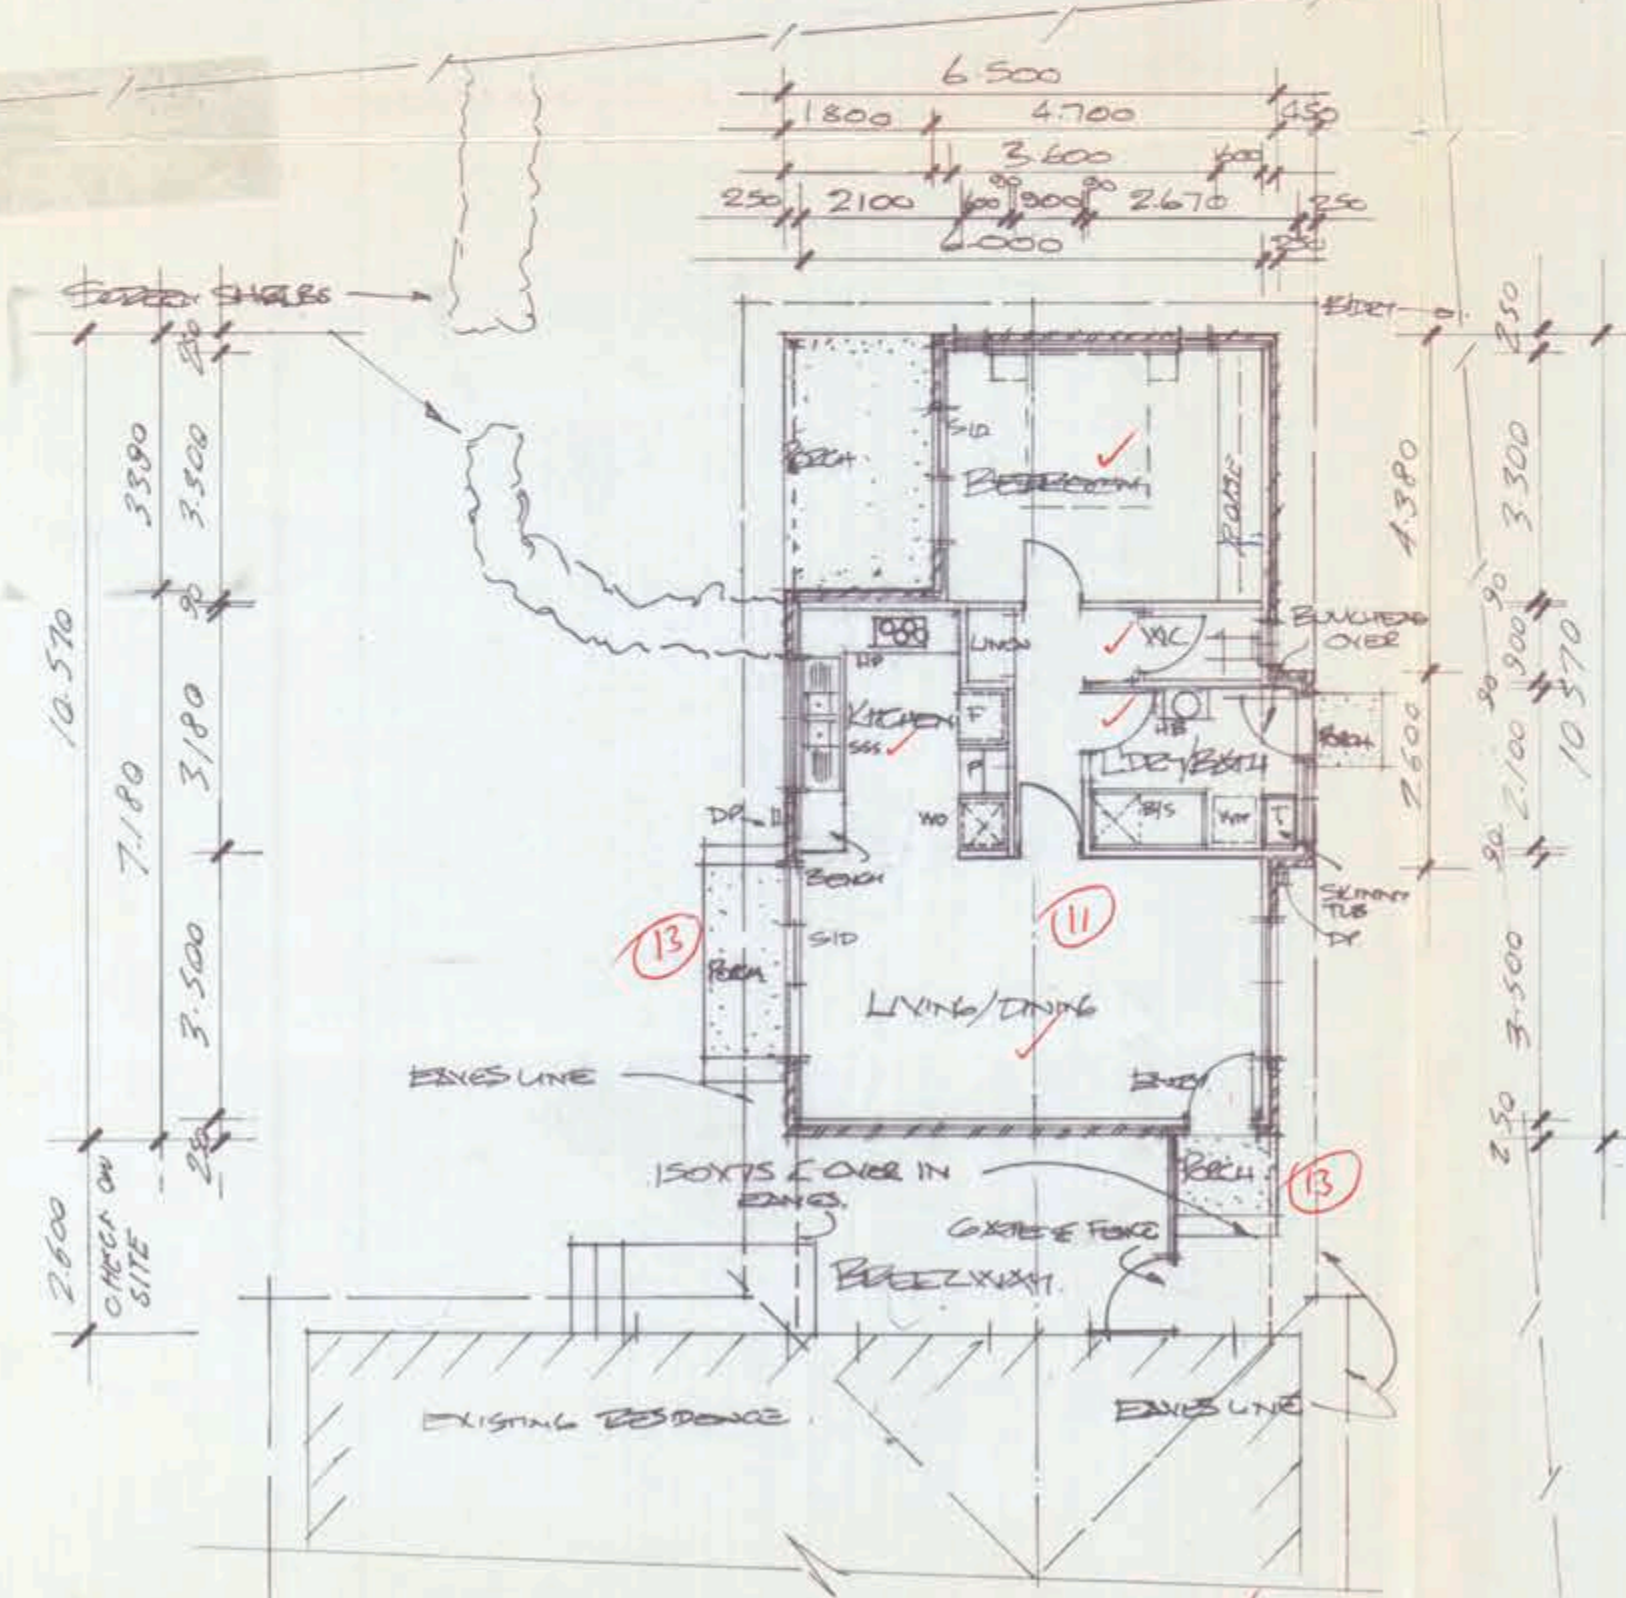
GENERAL FLOOR PLAN 1:100 ✓

Approx Area of Block = 761.25 M<sup>2</sup>  
Max P.R. of 35% = 266.43 M<sup>2</sup>  
Block Area - House = 113.68 M<sup>2</sup>  
Unit = 63.75 M<sup>2</sup>  
3 Car Spaces = 42.90

TOTAL SPACE USED = 220.33 M<sup>2</sup>  
Plot Ratio of 29.0%

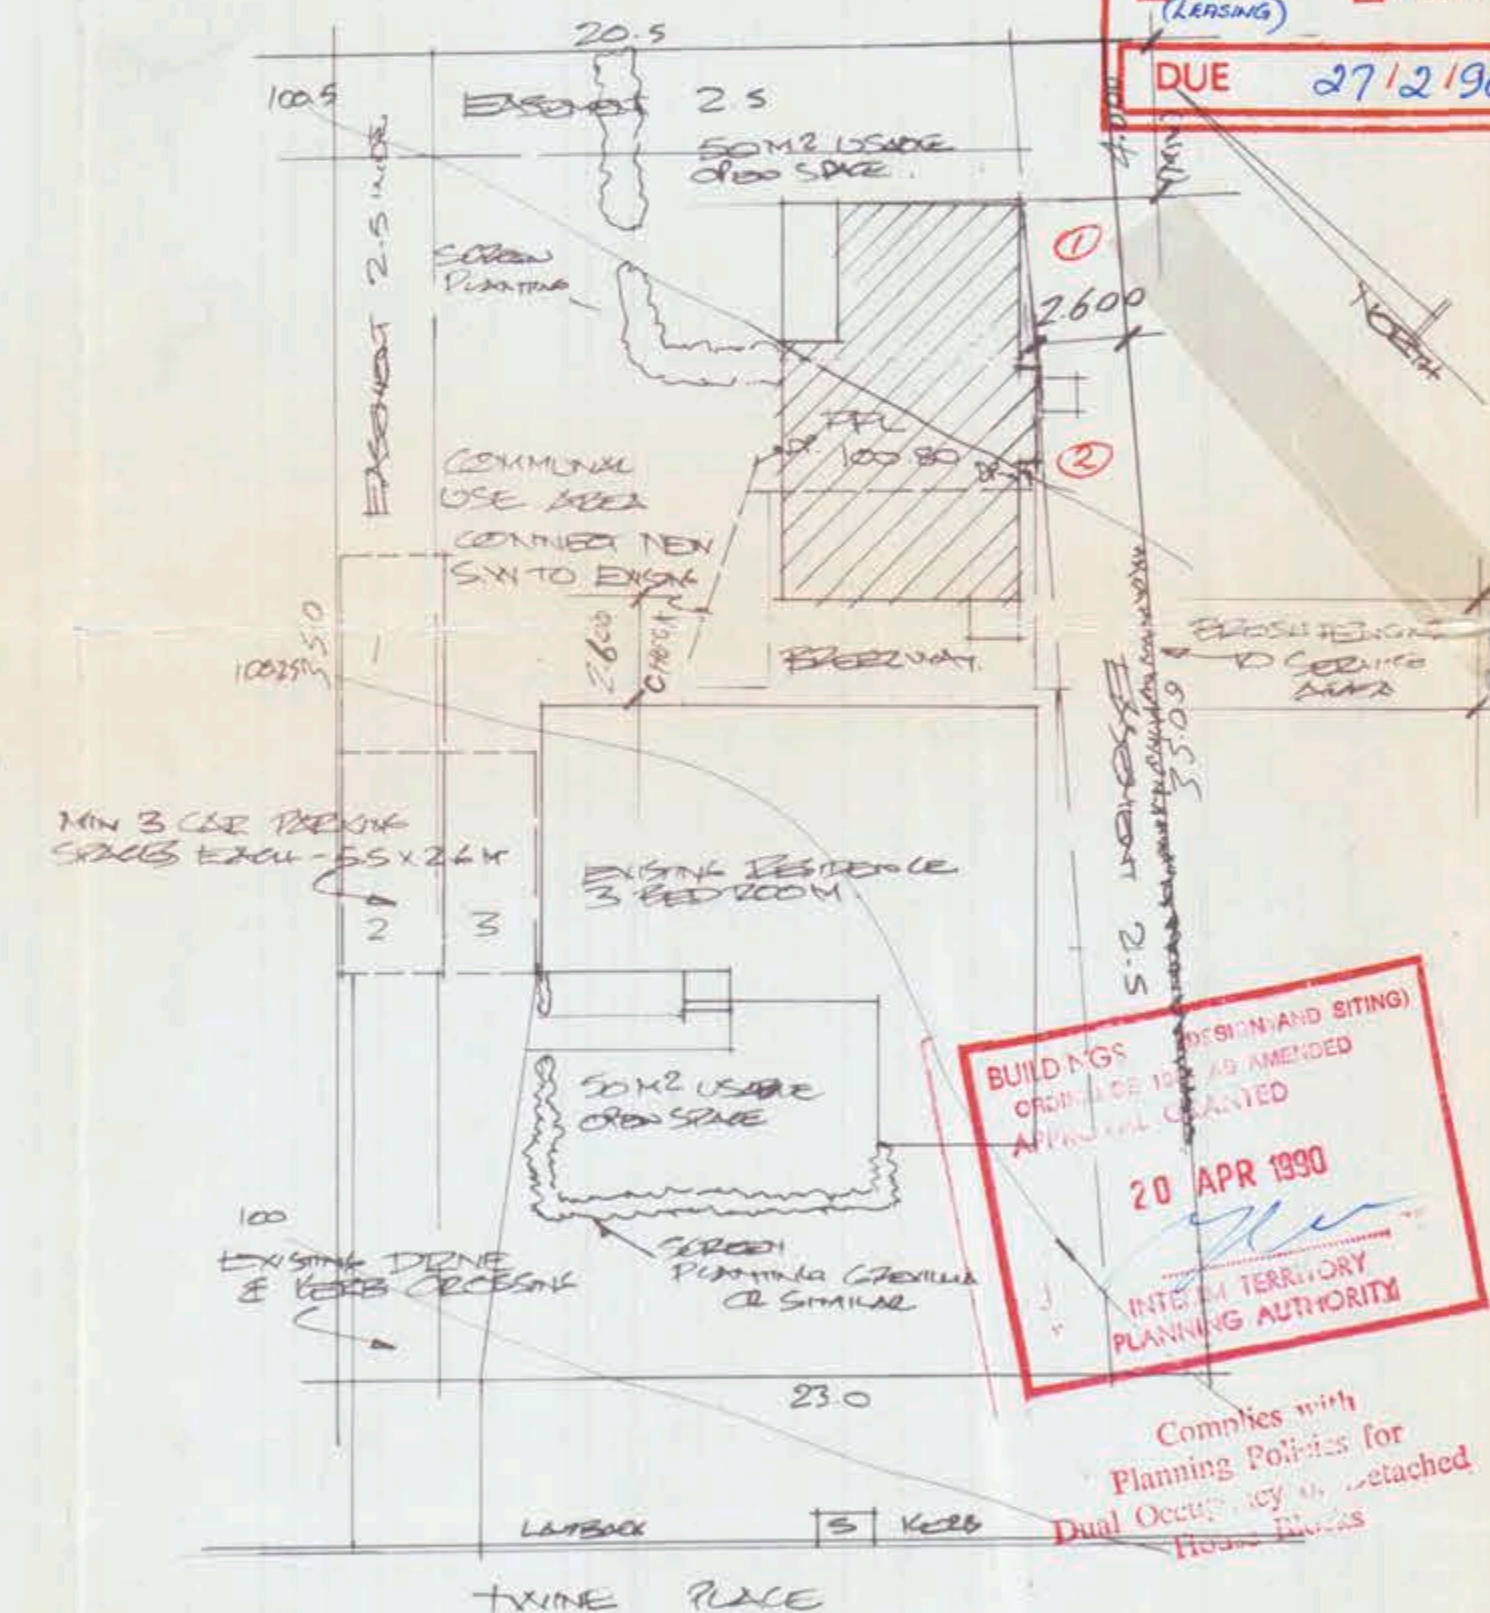
SITE PLAN 1:200

(REVISED FEB 1990) (1) - UNIT TESTED, (2) - LITEN/BATH & KITCHEN CHANGED.

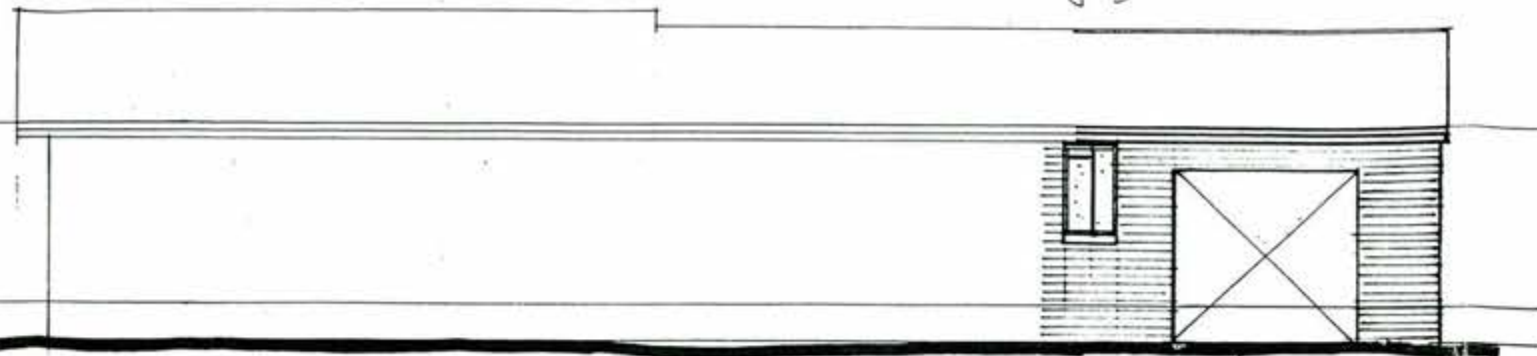
north east elevation:

2200 high roller door

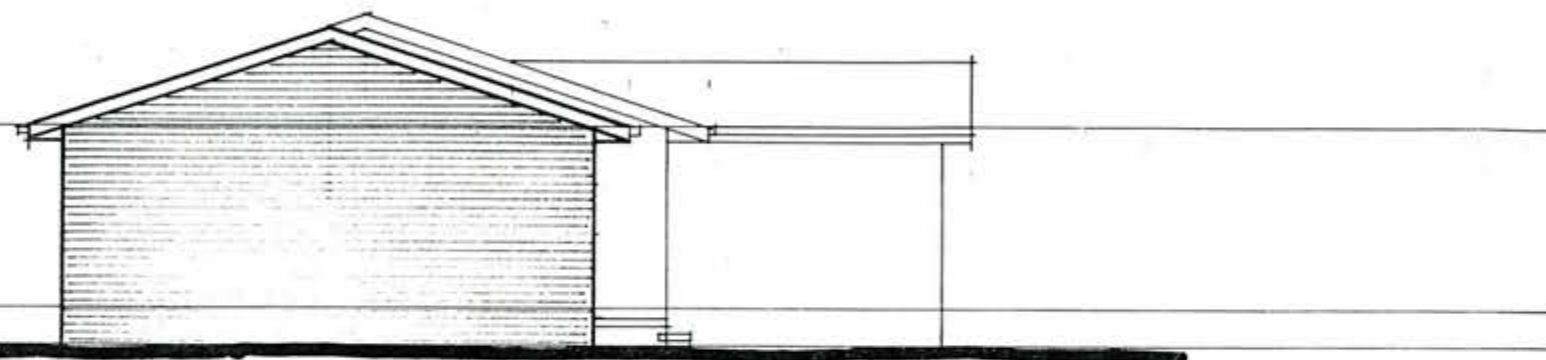
north west elevation face brickwork to match  
existing as closely as possible

concrete roof tiles to match  
existing as closely as possible.

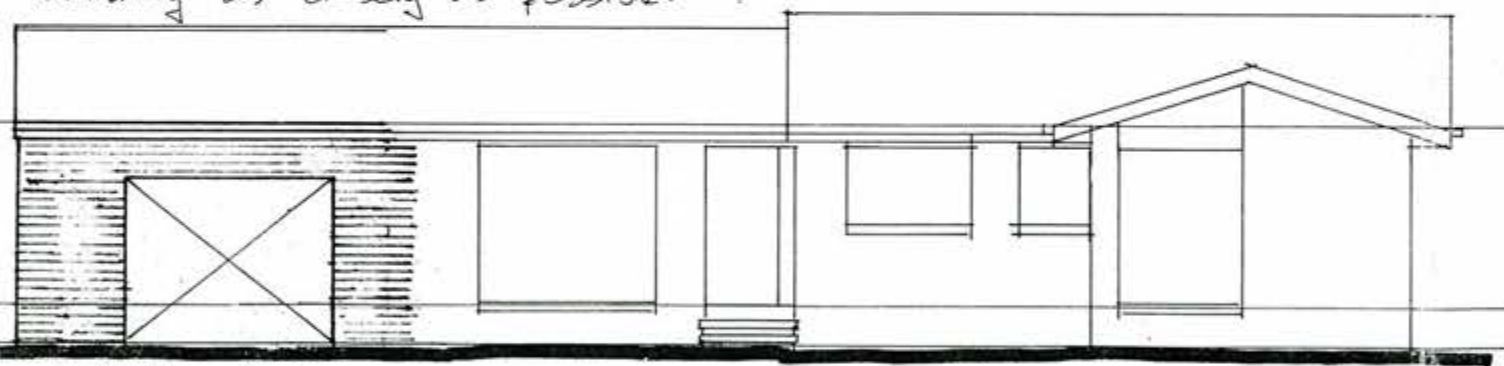
2200 high roller door  
south west elevation

Roof trusses at max 900 c/c installed to manufacturer's instructions

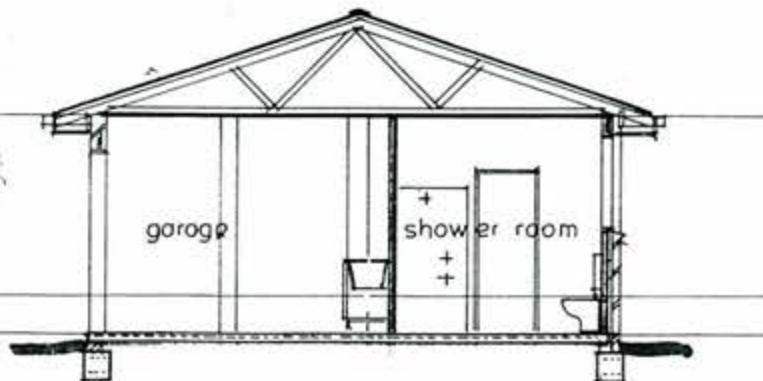
section 'a-a'

90 x 45 radiata pine wall plates fixed to brickwork with hoop iron  
holding down straps built min 1800 down into brick piers

Concrete strip footings & floor slabs in accordance with AS 2870.1:  
RESIDENTIAL SLABS & FOOTINGS, Part 1: CONSTRUCTION or to  
Engineer's site instructions

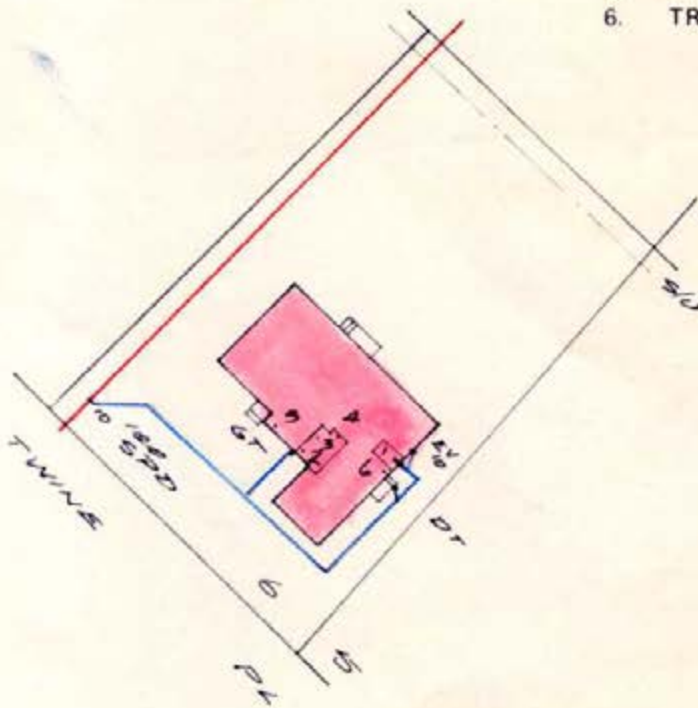
**NOTES:** DRAINS TO BE LAID ARE SHOWN IN BLUE LINES. THIS PLAN TO BE READ IN CONJUNCTION WITH APPROVED ARCHITECTURAL PLANS AND SPECIFICATIONS.  
DRAINS TO BE DELETED SHOWN BY RED X. EXISTING DRAINS SHOWN IN GREEN LINES.  
POSITION OF BRANCH TO BE LOCATED BEFORE ANY WORK IS COMMENCED.  
DRAINS TO BE LAID IN (U.P.V.C.) UNPLASTICISED POLYVINYL CHLORIDE IN ACCORDANCE WITH A.S.A. CA 67-1972 AND CANBERRA CODE OF PRACTICE ISSUE 1 JULY 1974.

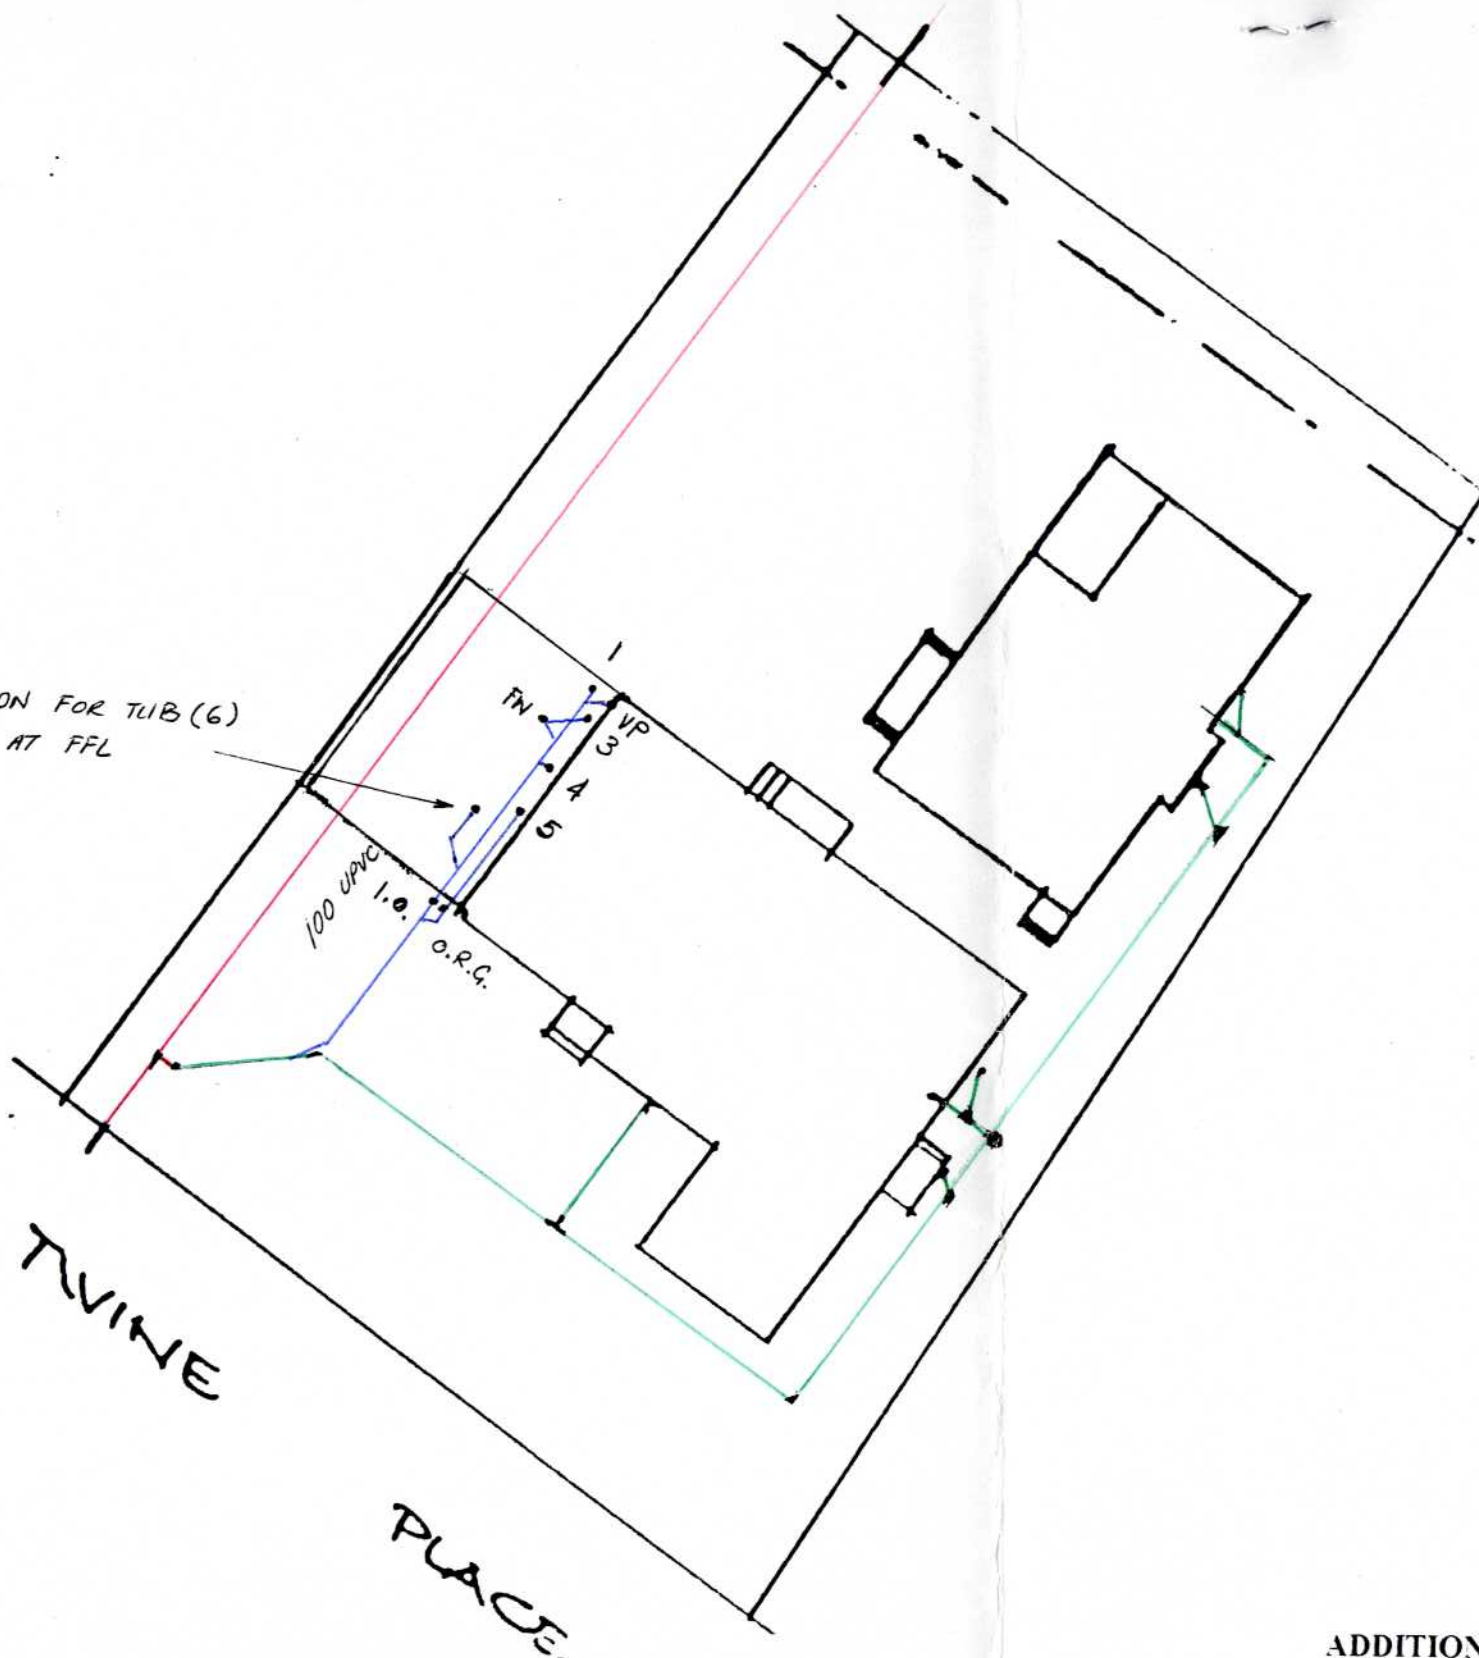
- All work to be executed in accordance with the Canberra Sewerage and Water Supply regulations.
- This plan is to be read in conjunction with the approved Building plans and specifications.
- Drains to be laid are shown in blue lines. Existing drains are shown in green lines.  
 Drains to be deleted are shown by red 'x'. Sewer mains are shown in red lines.  
 Cold water to be laid is shown in brown lines. Water mains are shown in blue lines.  
 Fire mains to be laid are shown in blue lines. Stormwater mains are shown in green lines.
- Sewer drainage pipes shall be UPVC to AS1260. Waste pipes shall be UPVC to AS1415.  
 Water supply pipes shall be Type B copper tube to AS 1432.
- Inspection openings are to be provided in accordance with AS 3500.
- All drains to be 100mm diameter unless noted otherwise.
- Sewer tie to be located prior to commencement of work.

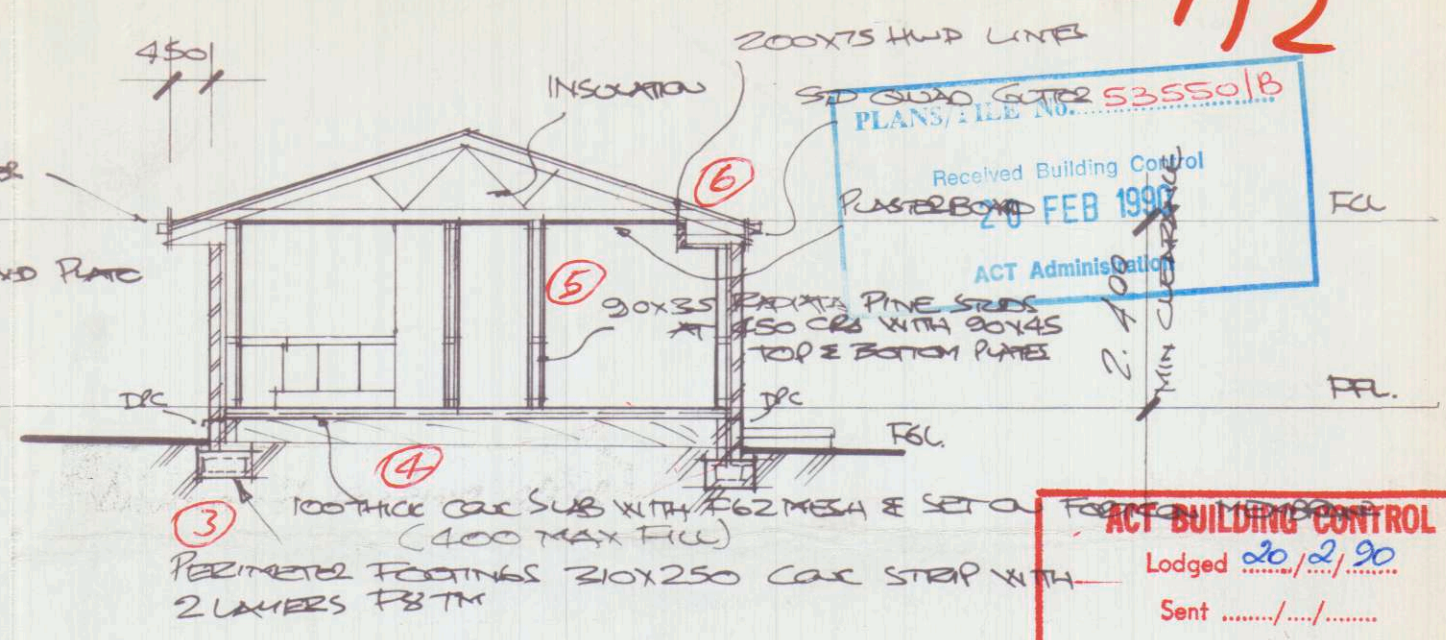
TYPICAL SECTION 1:100 ✓

Fire Resistance to Comply with Part C1.9 B.C.A.

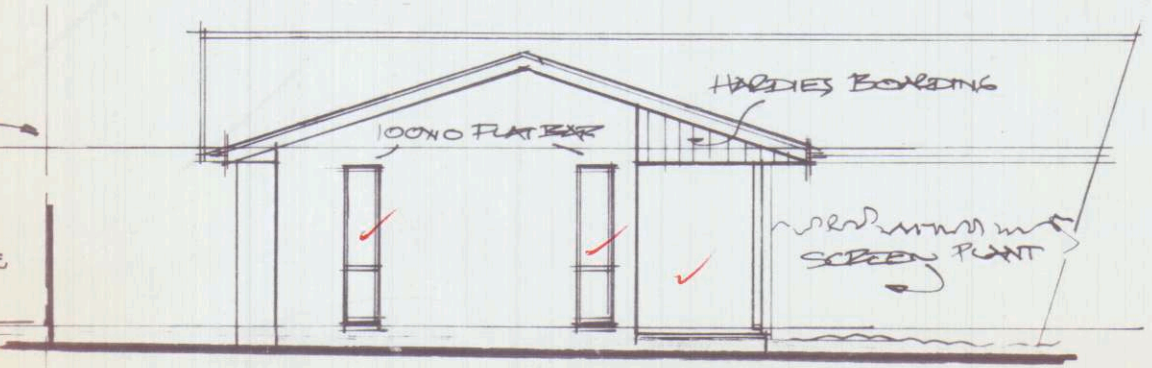
REAR ELEVATION 1:100 ✓

Damp & Water proofing TO COMPLY WITH PART F1 BUILDING CODE OF AUSTRALIA

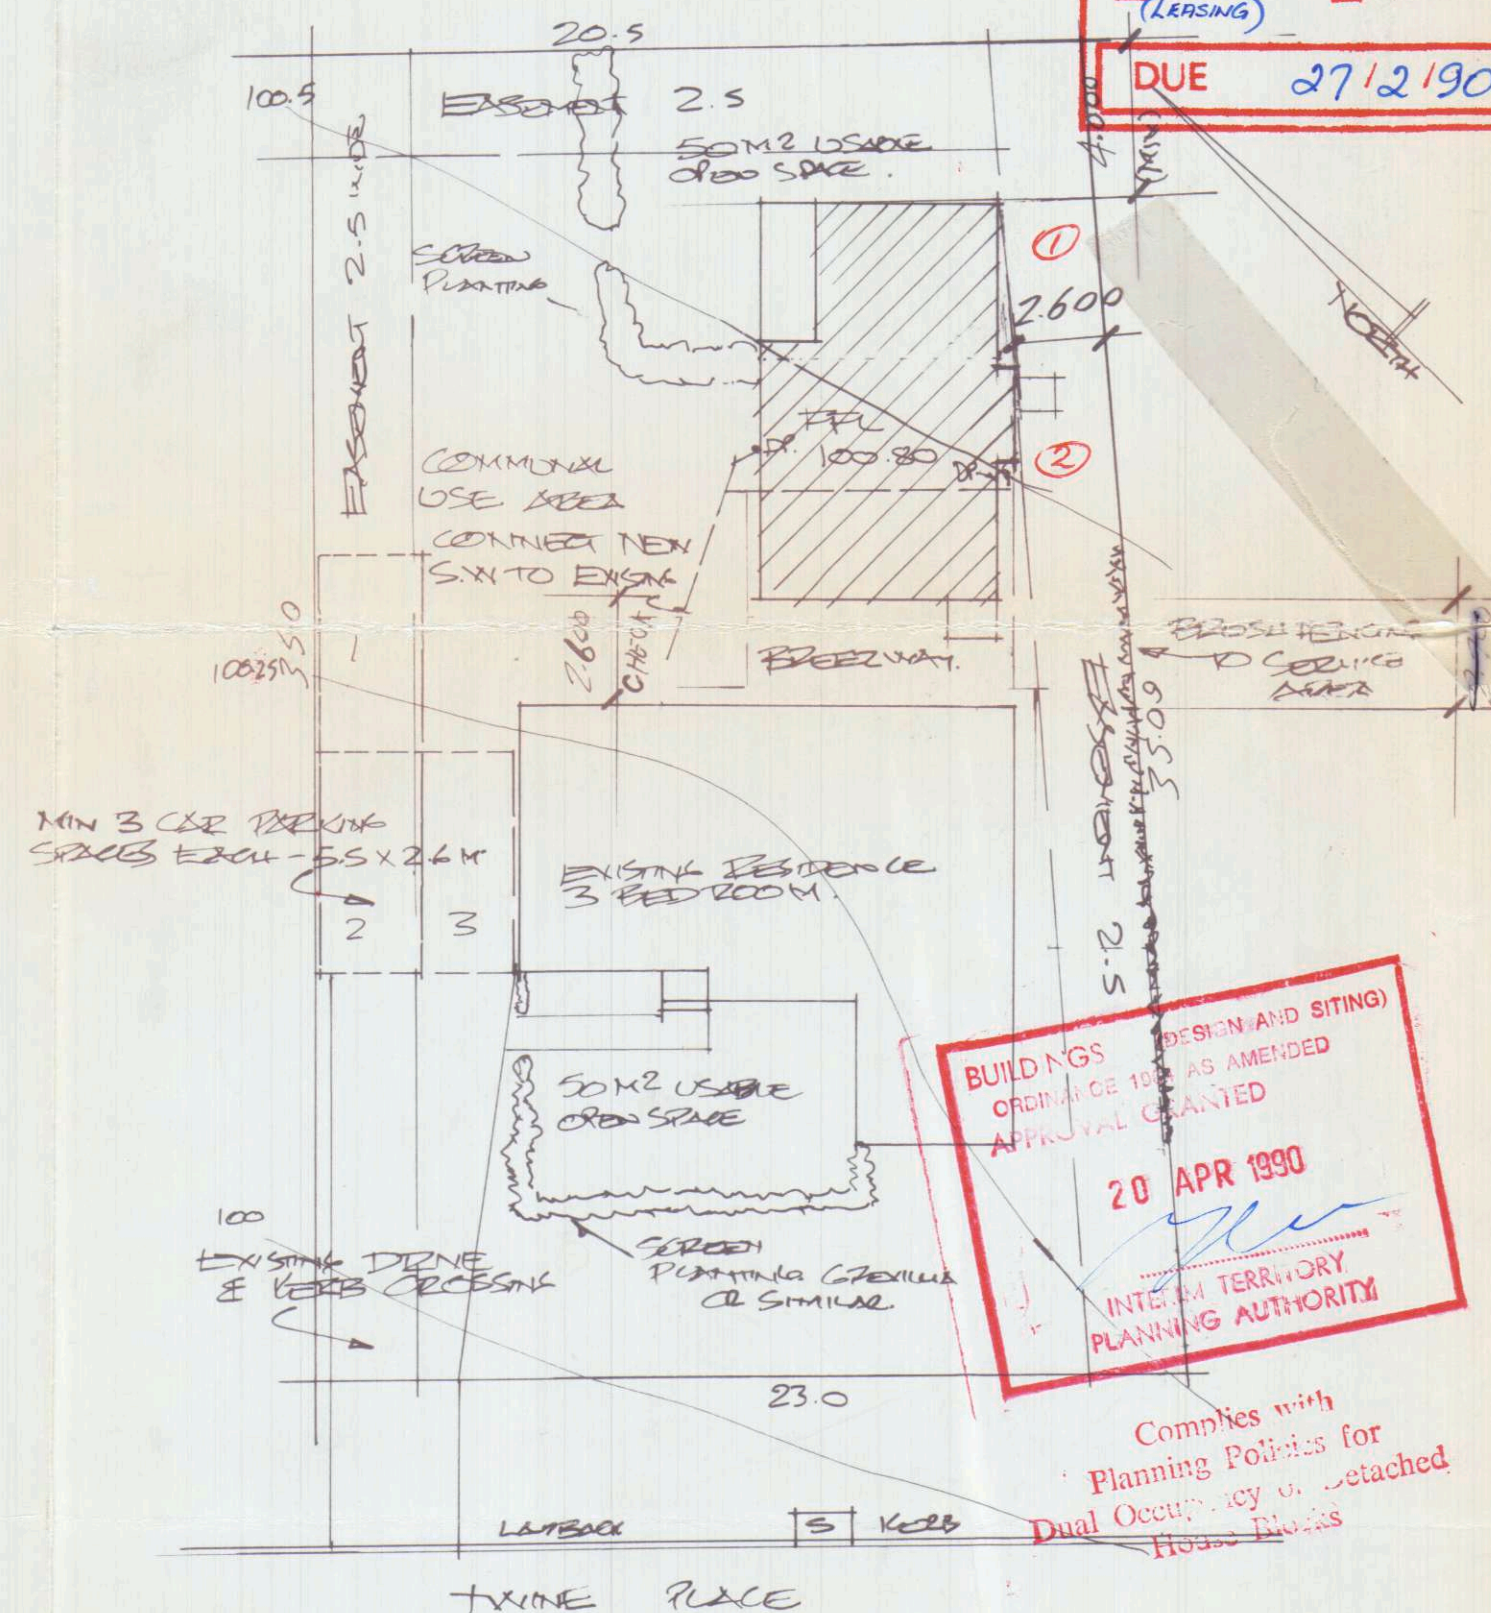
SITE PLAN 1:200  
 (REVISED FEB 1990) (1) - UNIT TESTED, (2) LITEN/BATH & KITCHEN CHANGED.

PROPOSE DUAL OCCUPANCY  
 AT : BLOCK 6, SECTION 102,  
 DIVISION OF MONASH

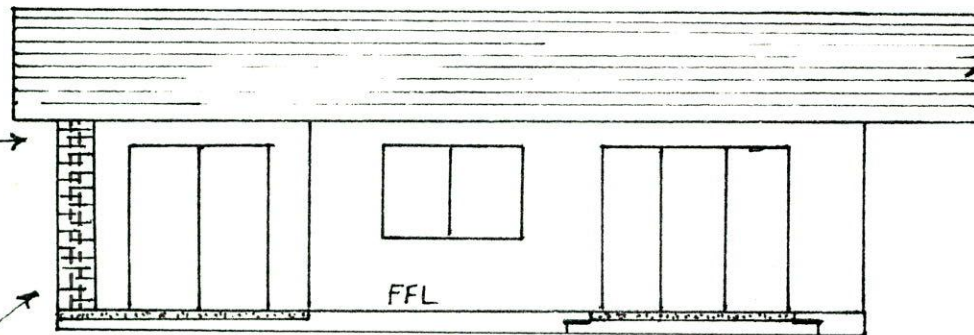
FRONT ELEVATION

FACE BRICKWORK AROUND POST

150x75 C  
OVER

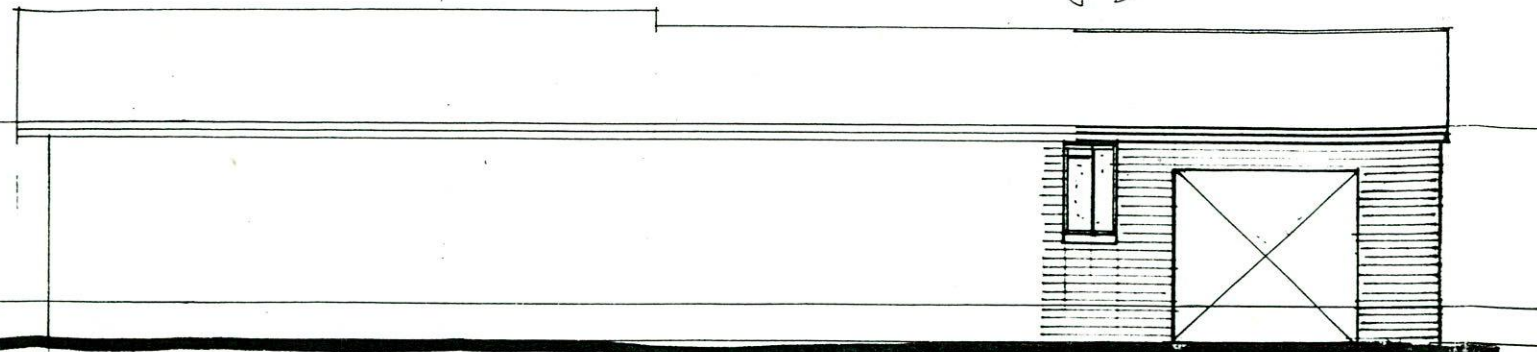
north east elevation:

aluminium framed obscure  
glazed window

2200 high roller door

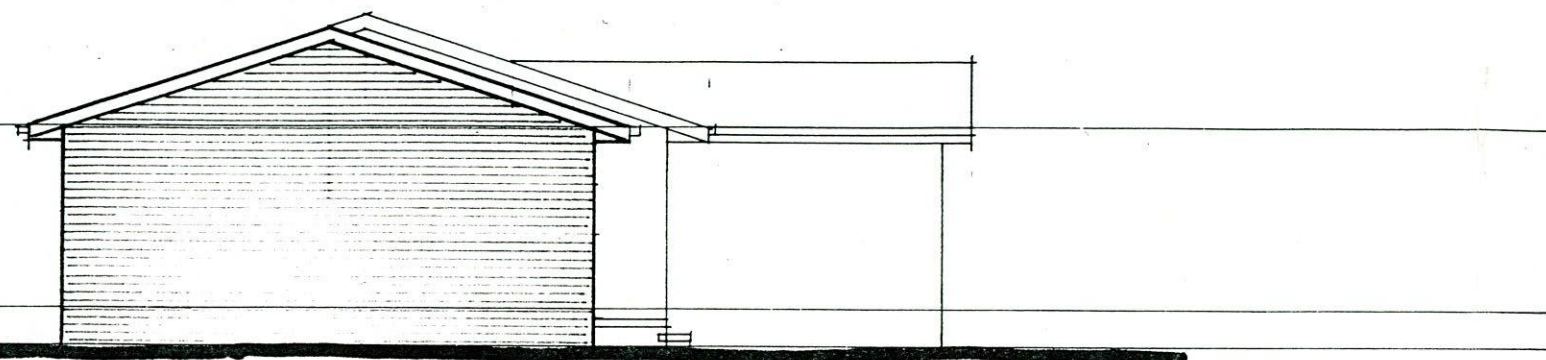
north west elevation face brickwork to match  
existing as closely as possible

concrete roof tiles to match  
existing as closely as possible

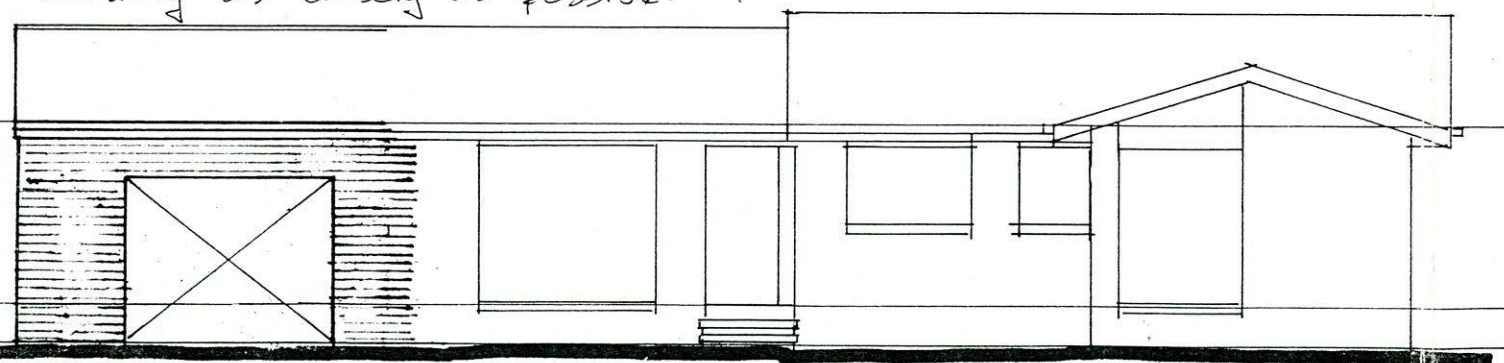
2200 high roller door  
south west elevation

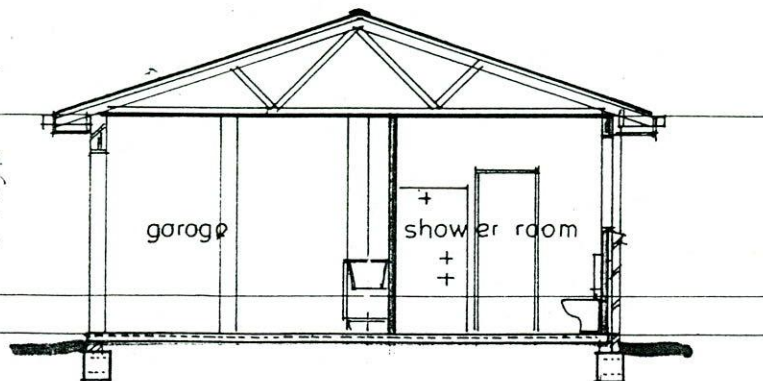
section 'a - a'

Roof trusses at max 900 c/c installed to manufacturer's instructions

90 x 45 radiata pine wall plates fixed to brickwork with hoop iron  
holding down straps built min 1800 down into brick piers

Concrete strip footings & floor slabs in accordance with AS 2870.1:  
RESIDENTIAL SLABS & FOOTINGS, Part 1: CONSTRUCTION or to  
Engineer's site instructions

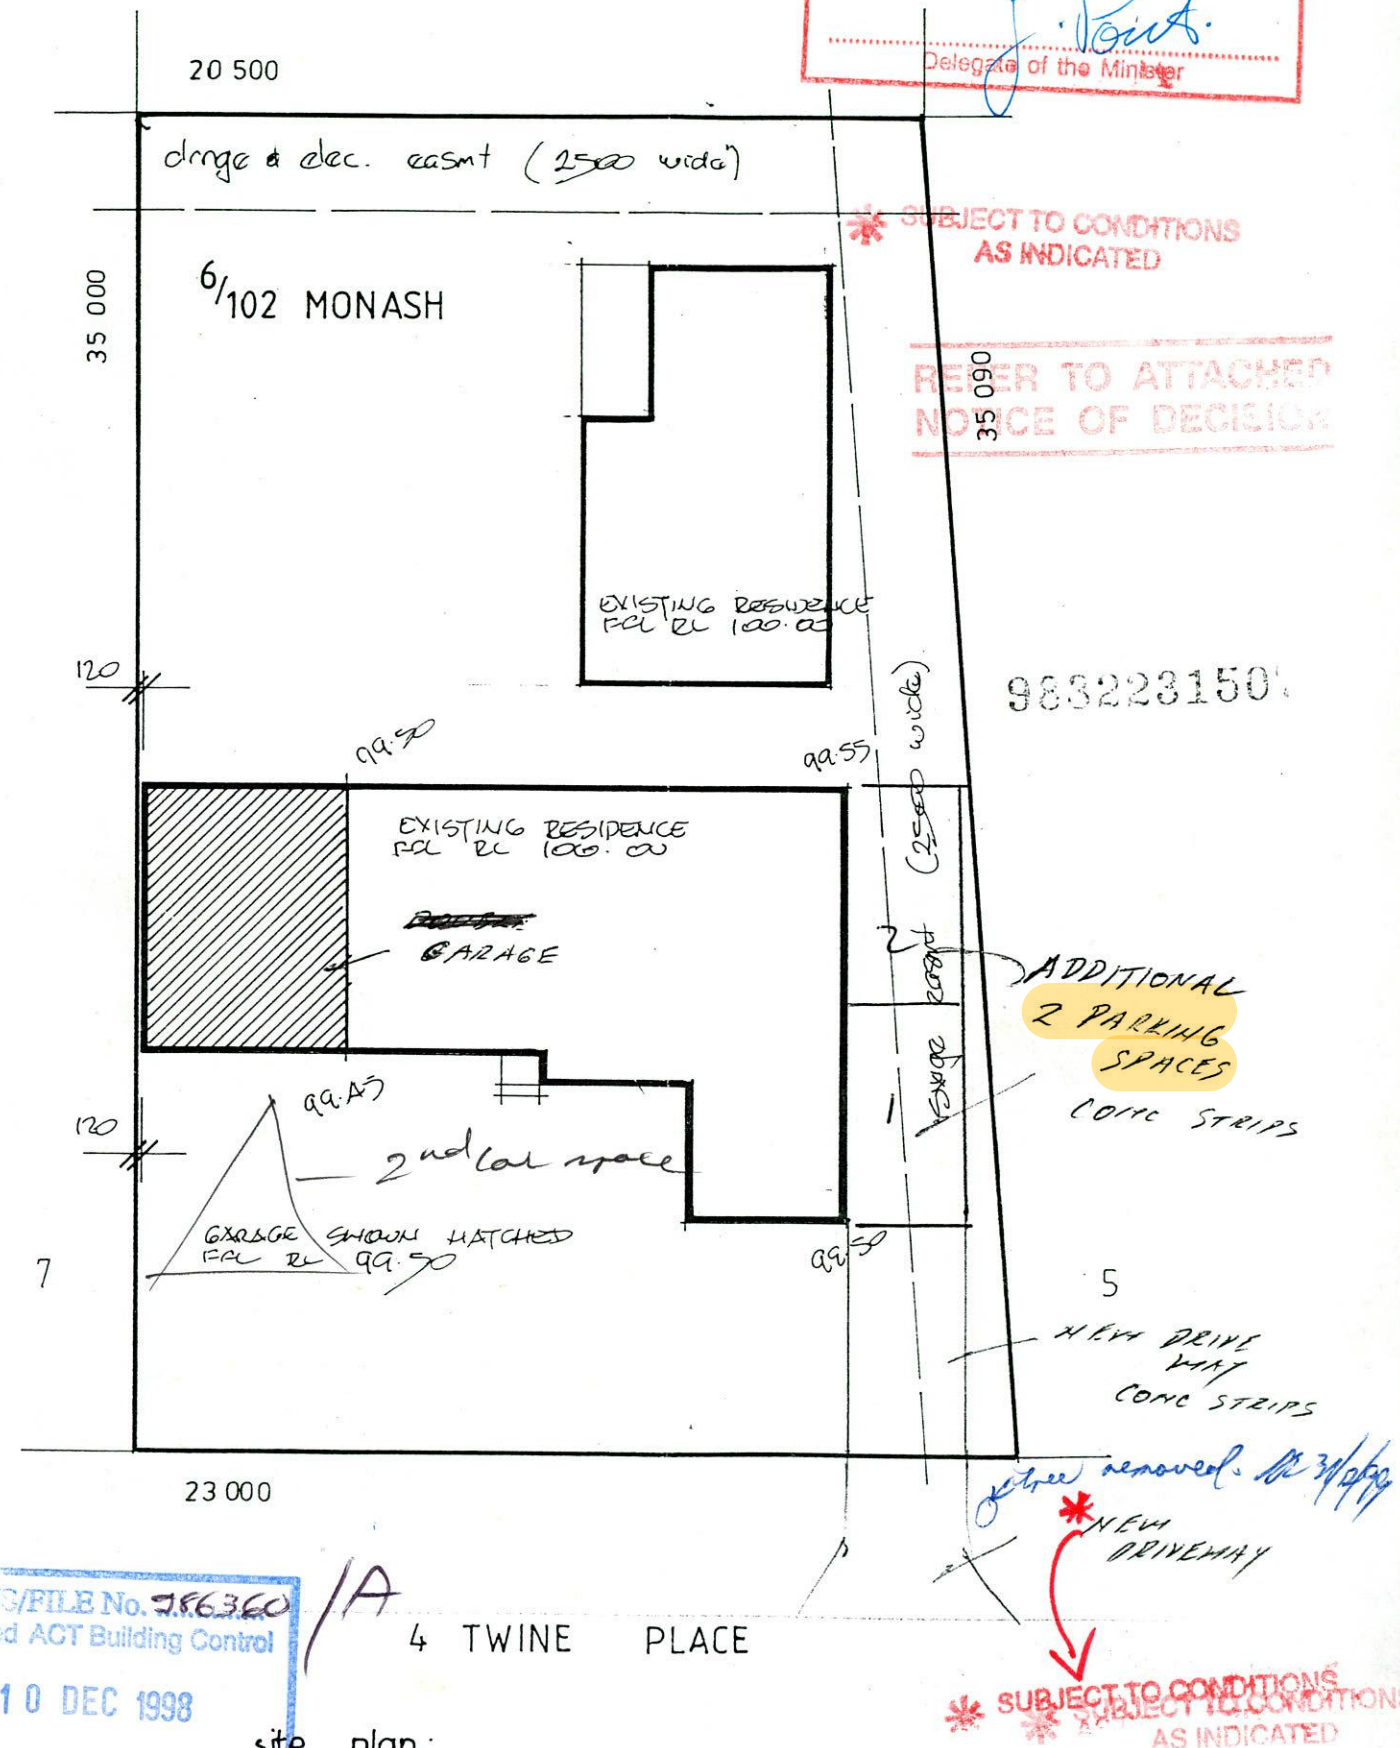
site plan:

scale: 1:200
