## PRESALE REPORT

**80 Dalley Crescent**

Latham

9 February 2026

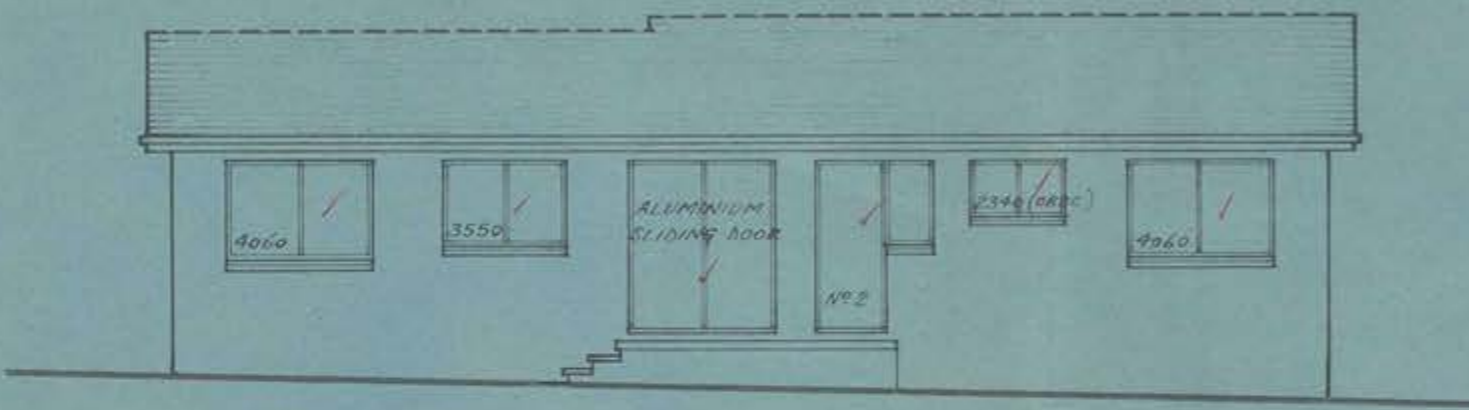
REAR ELEVATION

CEMENT TILES  
 ALUMINIUM WINDOWS  
 FACE BRICKWORK
